**Flood Control Project Maintenance
Levee Inspections**

Maintenance Issue Types Only, Levee Inspection Report By Mile - Spring 2017

Lake County Watershed Protection District

Waterway	Bank	Unit Miles	Inspection Start/End	Inspector
Unit No. 01 Middle Creek	Left	3.35	04/04/2017 04/04/2017	Bob Duffey

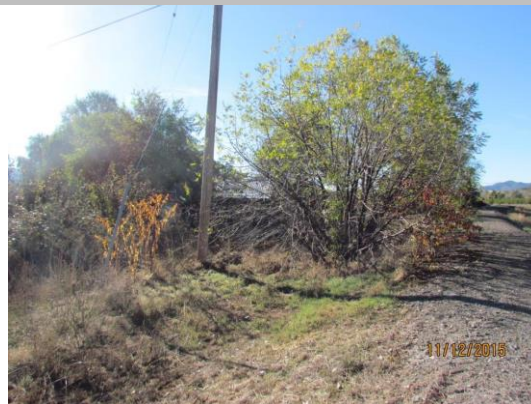
Photo 1 of 1 : SP_2017_NA0009_3_11_20170315_00006.jpg

LM Start	0.26	Rating **	M	Issue No.	11
LM End	0.26	Issue Type +	Ma	Location *	LS
Category	Earthen Levee			GPS Latitude/Longitude	
				Start	End
Item	Trim / Thin Trees			39.186777 °	39.186777 °
				-122.908102 °	-122.908102 °
DWR ID	DWR_NA0009_01_s_2013_11				
Comment Code					
T3 : Trim and thin trees to allow visibility of the ground and room to flood fight.					
Inspector Comment

View of the overgrown trees at the landside slope.

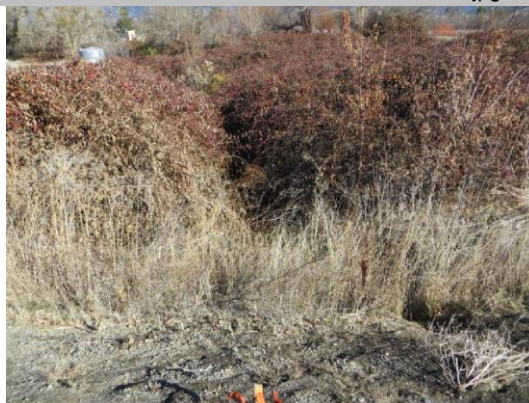
Photo 1 of 3 : UCIP_SP_2017_26987_49853.jpg

LM Start	2.26	Rating **	A/W	Issue No.	537
LM End	2.26	Issue Type +	Ma	Location *	LS
Category	Supplemental			GPS Latitude/Longitude	
				Start	End
Item	DWR UCIP LMA Responsibility			39.160327 °	39.160327 °
				-122.913998 °	-122.913998 °
DWR ID					
Comment Code					
Inspector Comment					
FS_ID:26987					
DS_ID:21240					
EP_NO: N/A					
Repair Type: No Action Needed					
Crossing Status: Found					
UCIP Comments:					
FIELD_STRUCT_DESC: 2 of 2: 36-inch CM drainpipe through the					
levee, 9.0 feet below the crown. Flap gate on the waterward end.					
Concrete headwalls on both ends. Originally listed in 1961 O+M					
manual. Pipes retained through levee under ABO No. 11460 (1975).					
FS Date: 1/14/2014

Pipe and Concrete headwall visible on LS toe.

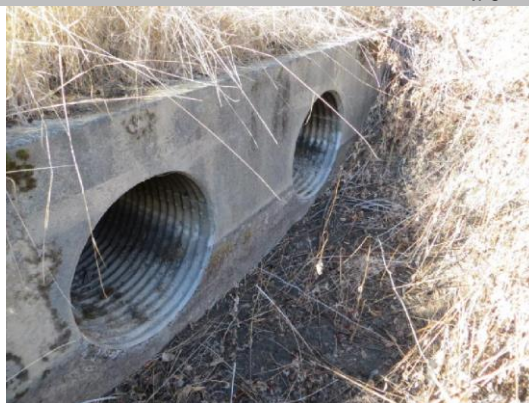
Photo 2 of 3 : UCIP_SP_2017_26987_49852.jpg

Pipe and Concrete headwall visible on LS toe.

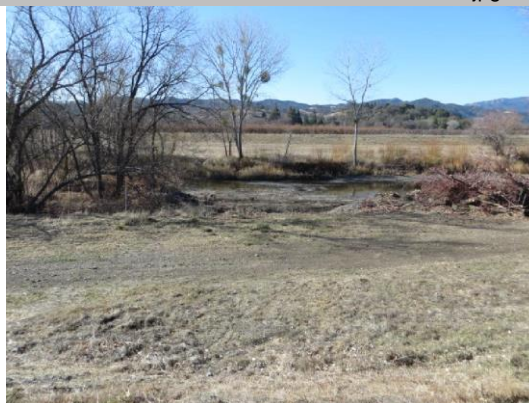
Photo 3 of 3 : UCIP_SP_2017_26987_49851.jpg

Pipe, Concrete headwall, and flap gate visible on WS berm.

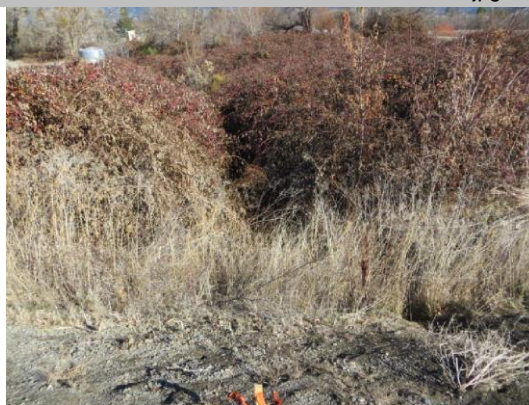
Photo 1 of 3 : UCIP_SP_2017_26986_49849.jpg

LM Start	2.26	Rating **	A/W	Issue No.	538
LM End	2.26	Issue Type +	Ma	Location *	LS
Category	Supplemental			GPS Latitude/Longitude	
				Start	End
Item	DWR UCIP LMA Responsibility			39.160272 °	39.160272 °
				-122.913966 °	-122.913966 °
DWR ID					
Comment Code					
Inspector Comment					
FS_ID:26986					
DS_ID:21197					
EP_NO: N/A					
Repair Type: No Action Needed					
Crossing Status: Found					
UCIP Comments:					
FIELD_STRUCT_DESC: 1 of 2: 36-inch CM drainpipe through the levee, 9.0 feet below the crown. Flap gate on the waterward end.					
Concrete "U" headwalls on both ends. Originally listed in 1961 O+M manual. Pipes retained through levee under ABO No. 11460 (1975).					
FS Date: 1/9/2014

Concrete headwall and pipe visible on LS toe at end of drainage swale.

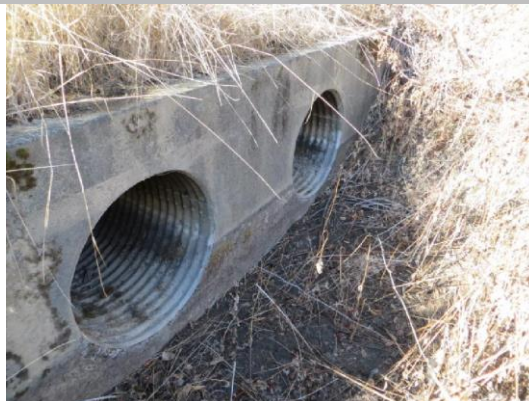
Photo 2 of 3 : UCIP_SP_2017_26986_49848.jpg

Concrete headwall and pipe visible on LS toe.

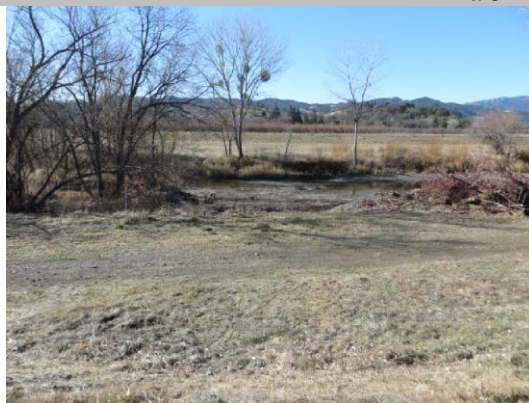
Photo 3 of 3 : UCIP_SP_2017_26986_49847.jpg

Concrete headwall and pipe visible on WS berm.

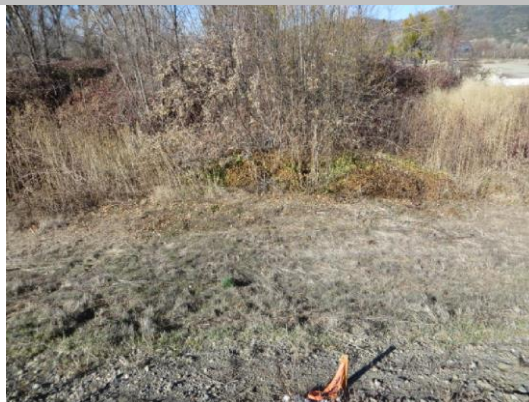
Photo 1 of 3 : UCIP_SP_2017_27004_49862.jpg

LM Start	2.35	Rating **	M	Issue No.	539
LM End	2.35	Issue Type +	Ma	Location *	WS
Category	Supplemental			GPS Latitude/Longitude	
				Start	End
Item	DWR UCIP LMA Responsibility			39.161002 °	39.161002 °
				-122.912843 °	-122.912843 °
DWR ID					
Comment Code					
Inspector Comment					
FS_ID:27004 DS_ID:21199 EP_NO: 11460 Repair Type: Non-Urgent Crossing Status: Found UCIP Comments: Heavy vegetation on LS at inlet should be removed. FIELD_STRUCT_DESC: 42-inch CM drainpipe through the levee, 10.0 feet below the crown. Flap gate on waterward end. Concrete headwall on both ends. Originally included in 1961 O+M manual. Pipe retained under ABO No. 11460 (1975). FS Date: 1/14/2014

Heavy vegetation at inlet on LS toe.

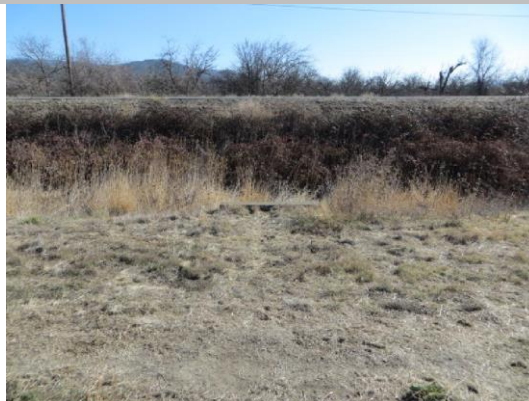
Photo 2 of 3 : UCIP_SP_2017_27004_49861.jpg

Concrete U-shaped headwall on WS berm.

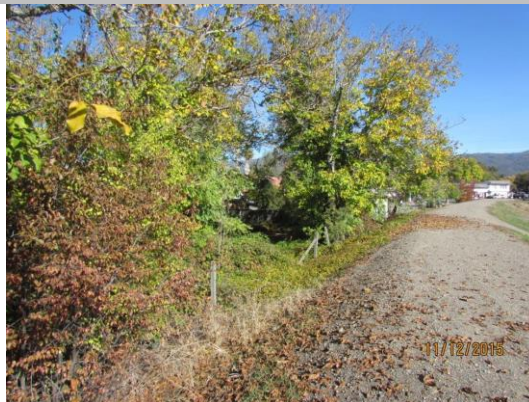
Photo 1 of 1 : SP_2017_NA0009_3_23_20170315_00013.jpg

View of the vegetation along the landside slope & toe.

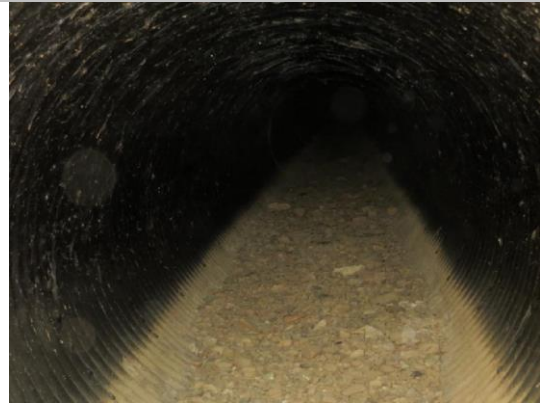
Photo 3 of 3 : UCIP_SP_2017_27066_50047.jpg

Pipe with some sediment at flowline.

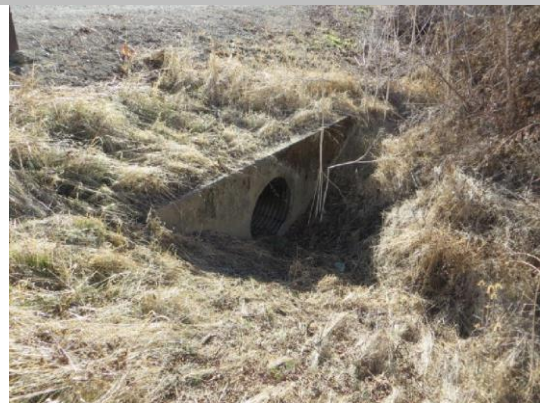
Photo 1 of 3 : UCIP_SP_2017_27184_50322.jpg

LM Start	0.24	Rating **	A/W	Issue No.	33
LM End	0.24	Issue Type +	Ma	Location *	LS
Category	Supplemental			GPS Latitude/Longitude	
				Start	End
Item	DWR UCIP LMA Responsibility			39.186794 °	39.186794 °
				-122.909413 °	-122.909413 °
DWR ID					
Comment Code					
Inspector Comment					
FS_ID:27184					
DS_ID:21204					
EP_NO: 11484					
Repair Type: No Action Needed					
Crossing Status: Found					
UCIP Comments:					
FIELD_STRUCT_DESC: 36-inch CM drainpipe through the levee, 6 feet below the crown. Flap gate on the waterward end. Concrete headwalls on both ends. Originally included in 1961 O+M manual. This pipe was retained under ABO No. 11484 (1975).					
FS Date: 1/14/2014

Concrete headwall and pipe on LS toe.

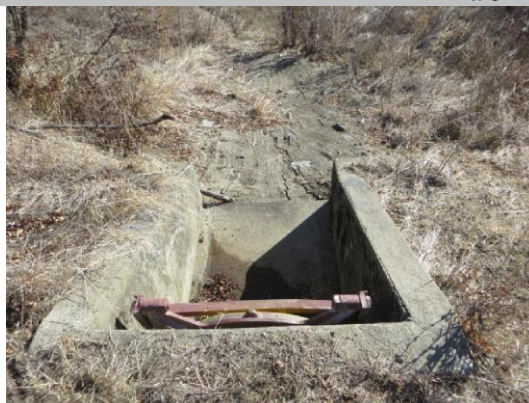
Photo 3 of 3 : UCIP_SP_2017_27184_50320.jpg

Flapgate and concrete headwall on WS toe.

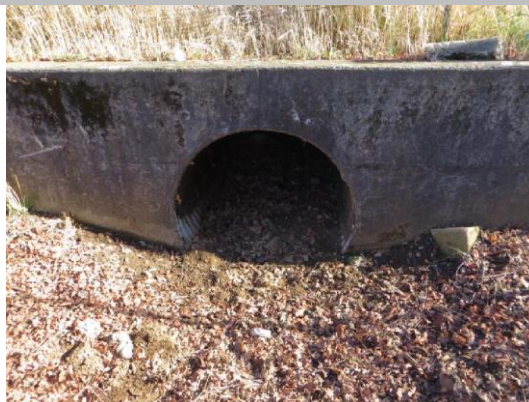
Photo 1 of 3 : UCIP_SP_2017_27199_50389.jpg

LM Start	0.48	Rating **	A/W	Issue No.	35
LM End	0.48	Issue Type +	Ma	Location *	LS
Category	Supplemental			GPS Latitude/Longitude	
				Start	End
Item	DWR UCIP LMA Responsibility			39.184126 °	39.184126 °
				-122.912118 °	-122.912118 °
DWR ID					
Comment Code					
Inspector Comment					
FS_ID:27199					
DS_ID:21208					
EP_NO: 11480					
Repair Type: No Action Needed					
Crossing Status: Found					
UCIP Comments:					
FIELD_STRUCT_DESC: 42-inch CM drainpipe through the levee, 7.0					
feet below the crown. Flap gate on the waterward end. Concrete					
headwalls on both ends. (USACE-1961). This entry matches the					
Drainage or Irrigation Structure referenced in O&M manual (HLM 0.47).					
This pipe was retained under ABO No. 11480 (1975).					
FS Date: 1/14/2014

Concrete headwall on LS toe.

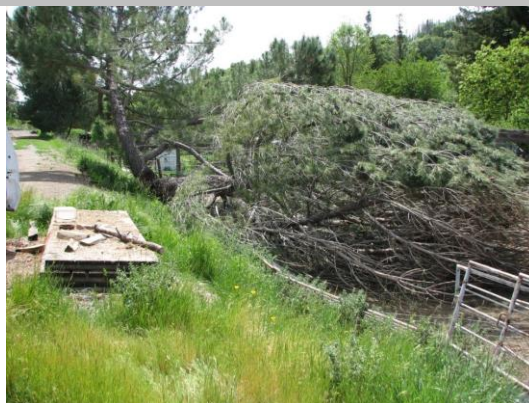
Photo 1 of 1 : SP_2017_NA0009_4_20_20170315_00011.jpg

View of the fallen tree branch on landside slope and toe.

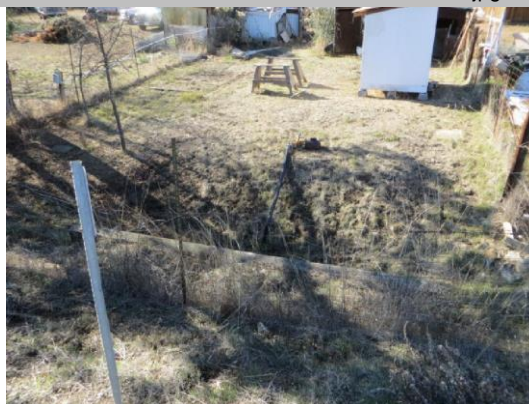
Photo 1 of 3 : UCIP_SP_2017_27208_50411.jpg

LM Start	0.55	Rating **	M	Issue No.	38
LM End	0.55	Issue Type +	Ma	Location *	LS
Category	Supplemental			GPS Latitude/Longitude	
				Start	End
Item	DWR UCIP LMA Responsibility			39.183130 °	39.183130 °
				-122.912198 °	-122.912198 °
DWR ID					
Comment Code					
Inspector Comment					
FS_ID:27208					
DS_ID:21210					
EP_NO: 11482					
Repair Type: Non-Urgent					
Crossing Status: Found					
UCIP Comments: Fence on LS slope creates access issue.					
FIELD_STRUCT_DESC: 36-inch CM drainpipe through the levee, 9.0					
feet below the crown. Flap gate on the waterward end. Concrete					
headwalls on both ends. (USACE-1961). This entry matches the					
Drainage or Irrigation Structure referenced in O&M manual (HLM 0.54).					
This pipe was retained under ABO No. 11482 (1975).					
FS Date: 1/14/2014

Concrete headwall on LS toe.

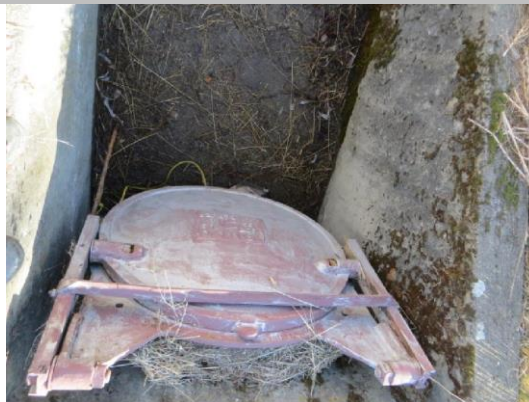
Photo 3 of 3 : UCIP_SP_2017_27208_50409.jpg

Flapgate and concrete headwall on WS berm.

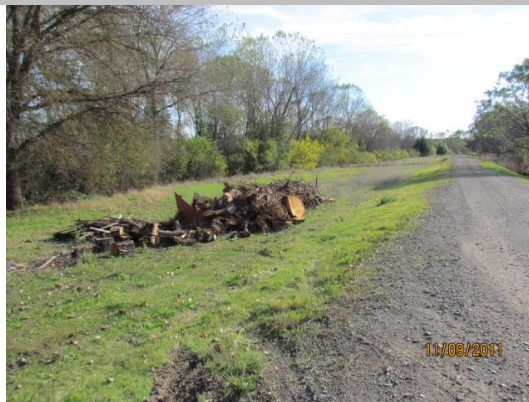
Photo 1 of 1 : SP_2017_NA0009_4_3_20170315_00003.jpg

View of the tree prunings on the W/S toe.

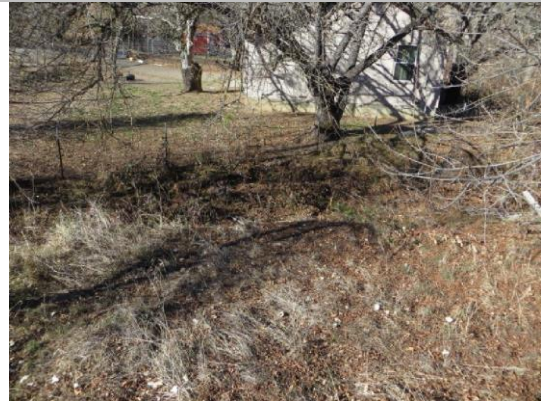
Photo 3 of 3 : UCIP_SP_2017_27583_51200.jpg

Pipe visible on LS toe.

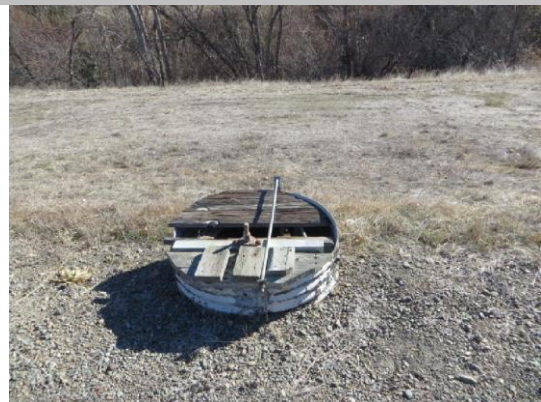
Photo 1 of 3 : UCIP_SP_2017_42994_51214.jpg

LM Start	1.16	Rating **	M	Issue No.	40
LM End	1.16	Issue Type +	Ma	Location *	WS
Category	Supplemental			GPS Latitude/Longitude	
				Start	End
Item	DWR UCIP LMA Responsibility			39.174370 °	39.174370 °
				-122.913543 °	-122.913543 °
DWR ID					
Comment Code					
Inspector Comment					
FS_ID:42994					
DS_ID:21212					
EP_NO: 11483					
Repair Type: Non-Urgent					
Crossing Status: Found					
UCIP Comments: Pipe appears abandoned and if so, should be done so properly. Debris blocking flapgate at outlet.					
FIELD_STRUCT_DESC: *ABANDONED* 30-inch CM drainpipe through the levee, 17.8 feet below the crown. Slide gate in 44-inch diameter CMP riser waterward slope. Flap gate on the waterward end at concrete headwall. 6'X8' concrete sump at landward toe. (USACE-1961). Originally included in O&M manual (HLM 1.22). This pipe was retained under ABO No. 11483 (1975).					
FS Date: 1/22/2014

Slide gate in 44-inch CMP riser on WS shoulder.

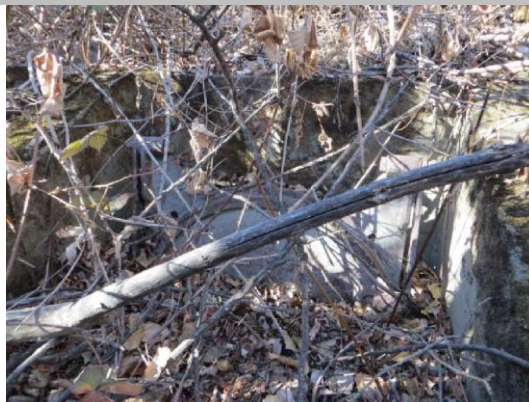
Photo 3 of 3 : UCIP_SP_2017_42994_51215.jpg

Flapgate and concrete headwall visible off WS berm.

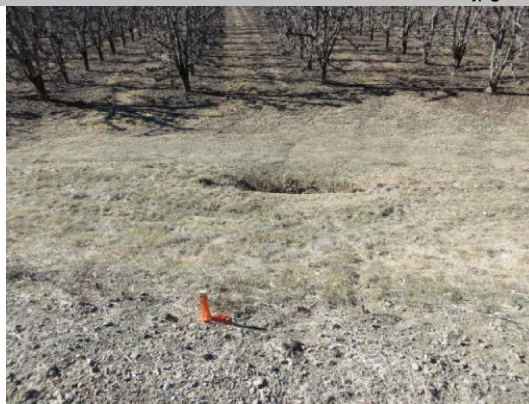
Photo 1 of 3 : UCIP_SP_2017_27630_51283.jpg

Concrete headwall and pipe visible at LS toe.

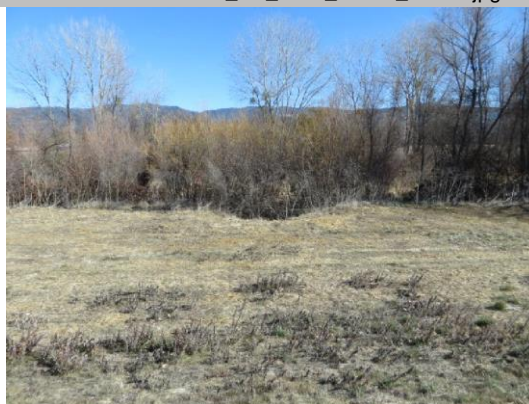
Photo 2 of 3 : UCIP_SP_2017_27630_51282.jpg

Concrete headwall and flapgate visible at WS berm.

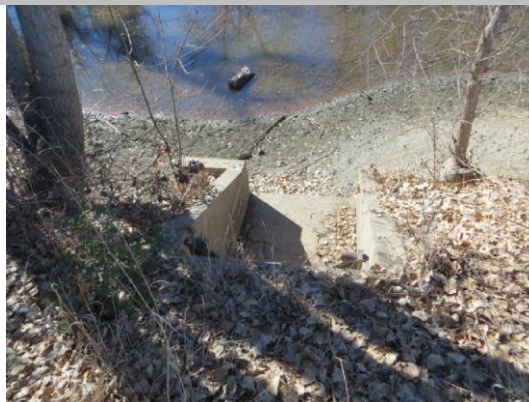
Photo 2 of 3 : UCIP_SP_2017_27863_51541.jpg

Concrete headwall and flapgate visible at WS berm.

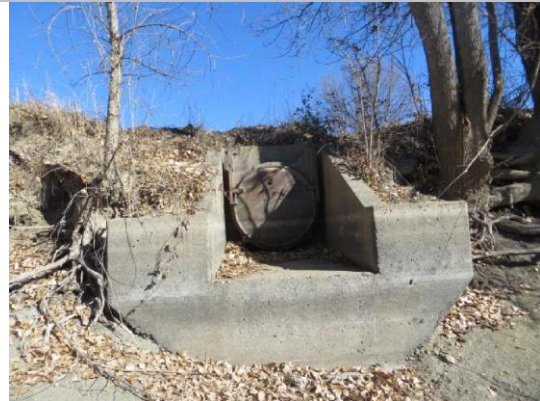
Photo 3 of 3 : UCIP_SP_2017_27863_51540.jpg

Concrete headwall and flapgate visible at WS berm.

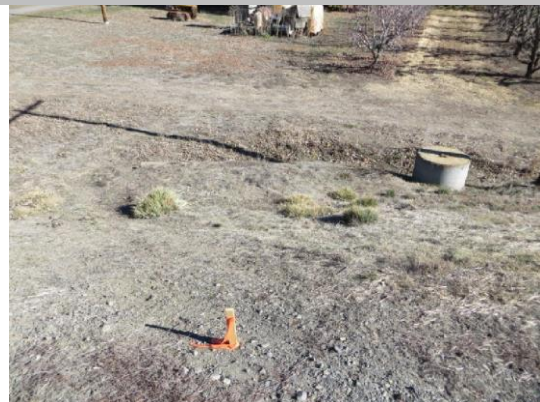
Photo 1 of 3 : UCIP_SP_2017_27892_51591.jpg

Concrete headwall visible next to concrete standpipe on LS toe.

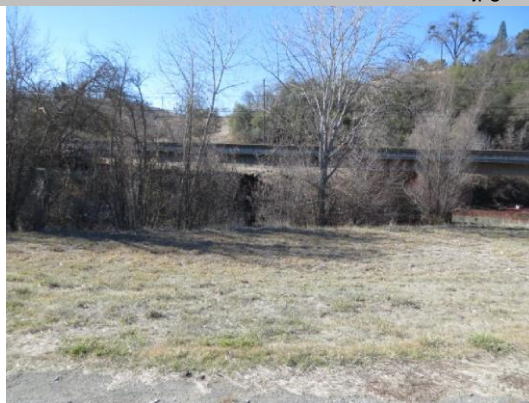
Photo 2 of 3 : UCIP_SP_2017_27892_51590.jpg

Concrete outfall visible off WS berm.

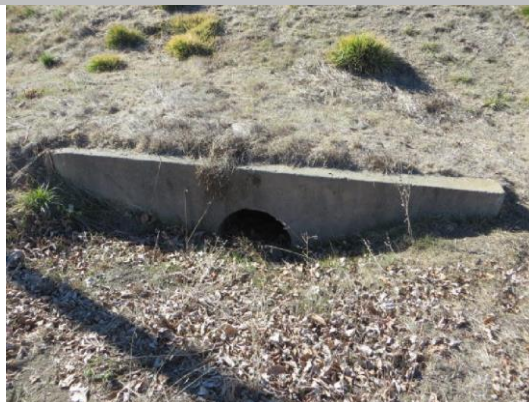
Photo 3 of 3 : UCIP_SP_2017_27892_51589.jpg

Concrete headwall visible at LS toe.

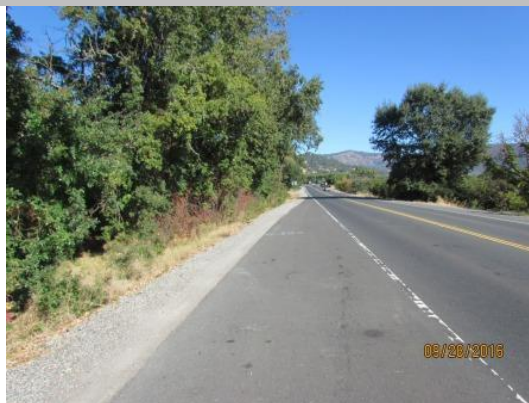
Photo 1 of 1 : SP_2017_NA0009_5_14_20170315_00005.jpg

View of the waterside vegetation looking upstream.

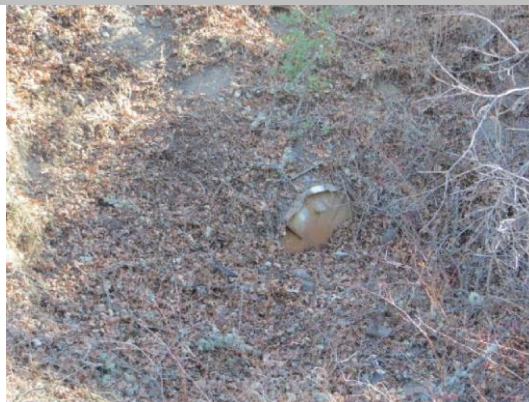
Photo 1 of 3 : UCIP_SP_2017_27893_51595.jpg

Plugged pipe visible on WS toe of roadway.

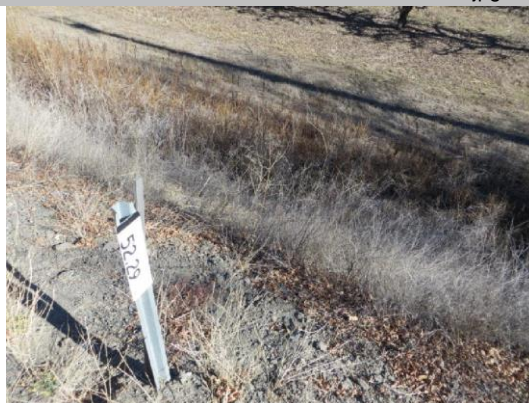
Photo 2 of 3 : UCIP_SP_2017_27893_51594.jpg

Roadway marker 52.29 on LS and WS shoulder mark pipe location on crown.

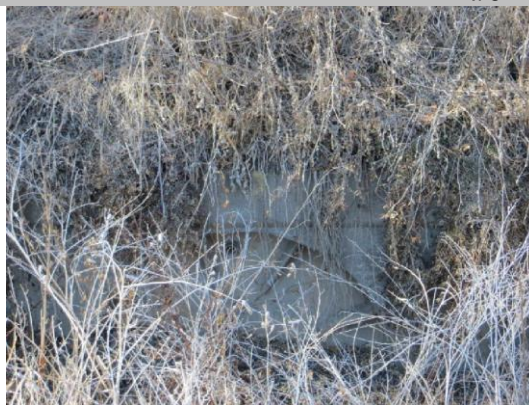
Photo 3 of 3 : UCIP_SP_2017_27893_51596.jpg

Concrete headwall and plugged pipe visible onLS toe of roadway.

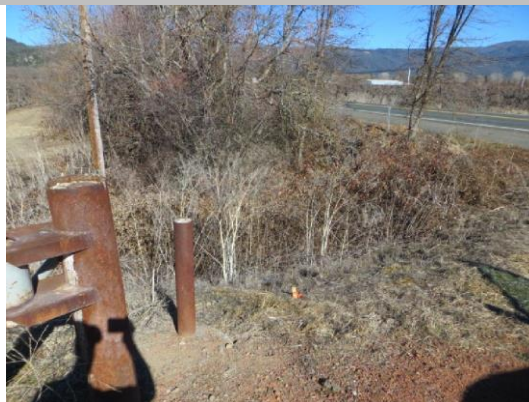
Photo 2 of 3 : UCIP_SP_2017_27894_51598.jpg

Concrete headwall on LS toe.

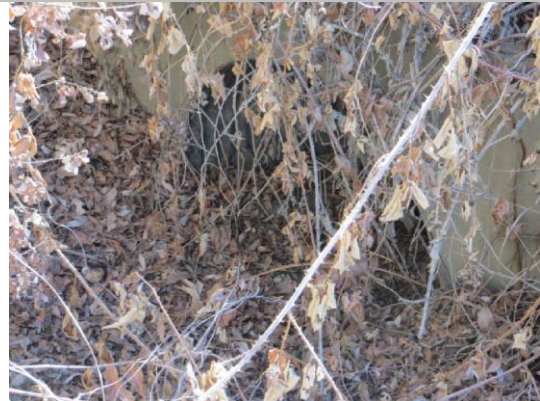
Photo 3 of 3 : UCIP_SP_2017_27894_51597.jpg

Concrete headwall on LS toe.

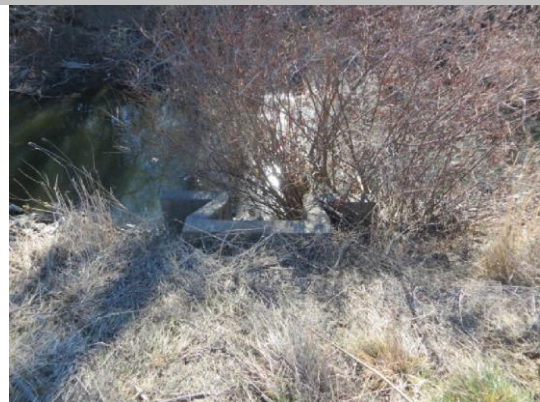
Photo 1 of 3 : UCIP_SP_2017_27943_51642.jpg

Concrete Headwall on WS berm.

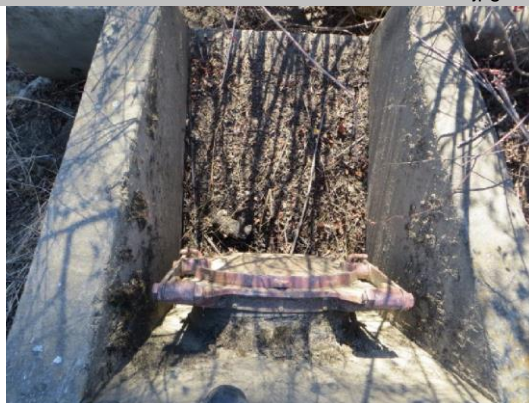
Photo 2 of 3 : UCIP_SP_2017_27943_51641.jpg

Headwall and flapgate on WS berm.

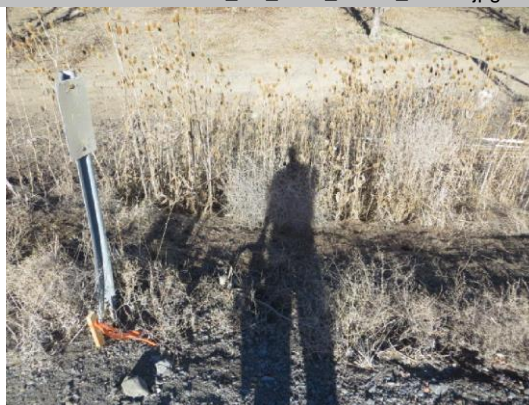
Photo 3 of 3 : UCIP_SP_2017_27943_51640.jpg

Pipe location marked on crown by flasher.

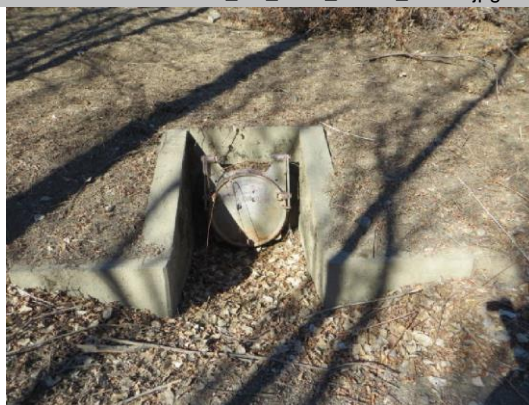
Photo 2 of 3 : UCIP_SP_2017_27944_51645.jpg

Flapgate and headwall visible on WS toe.

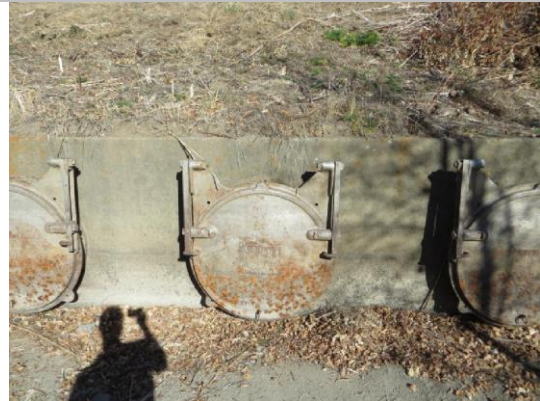
Photo 3 of 3 : UCIP_SP_2017_27964_51663.jpg

Flapgate and headwall on WS toe.

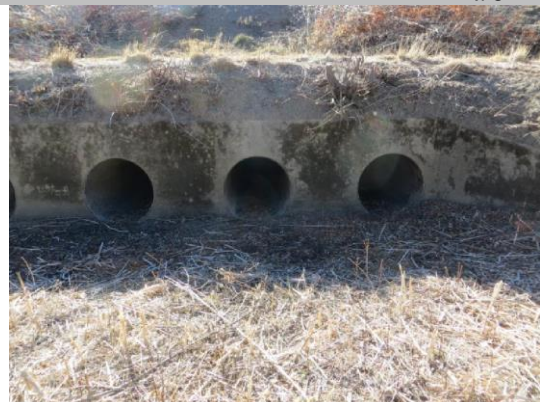
Photo 1 of 3 : UCIP_SP_2017_27965_51668.jpg

Pipe and concrete headwall on LS toe.

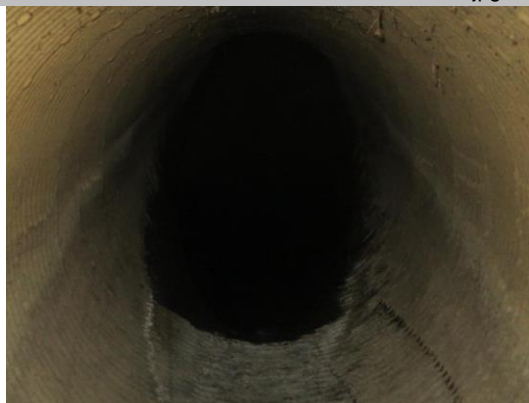
Photo 2 of 3 : UCIP_SP_2017_27965_51667.jpg

Pipe from LS toe.

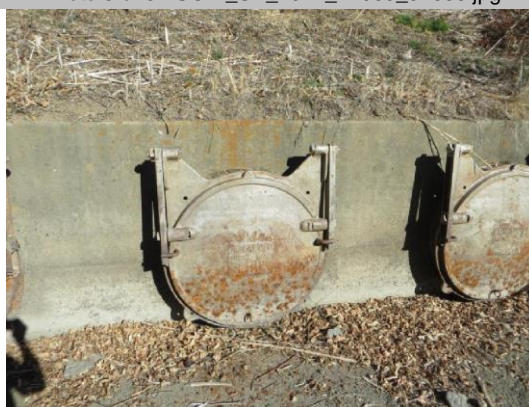
Photo 3 of 3 : UCIP_SP_2017_27965_51666.jpg

Flapgate on headwall at WS toe.

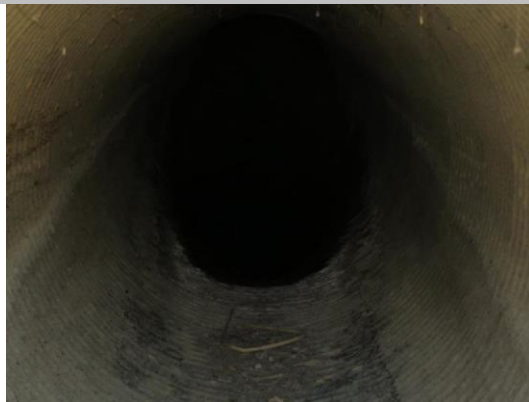
Photo 2 of 3 : UCIP_SP_2017_27967_51670.jpg

Pipe from LS toe.

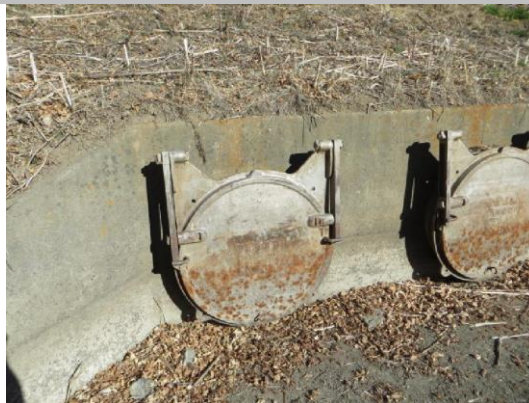
Photo 3 of 3 : UCIP_SP_2017_27967_51669.jpg

Flapgate on concrete headwall on WS toe.

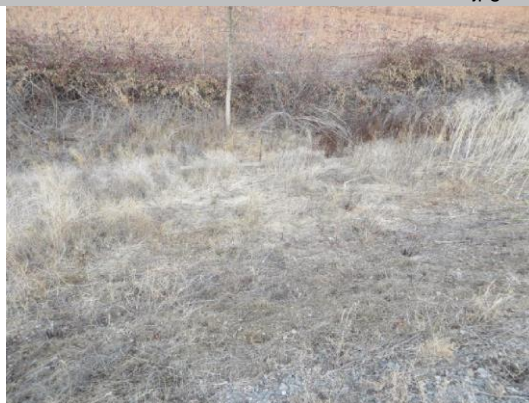
Photo 1 of 3 : UCIP_SP_2017_26947_49793.jpg

Concrete headwall visible on LS toe.

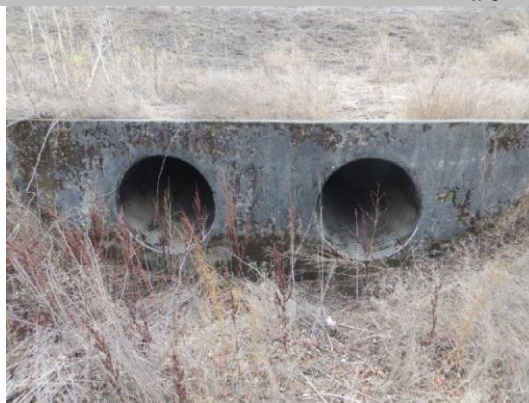
Photo 2 of 3 : UCIP_SP_2017_26947_49792.jpg

Concrete headwall visible on LS toe.

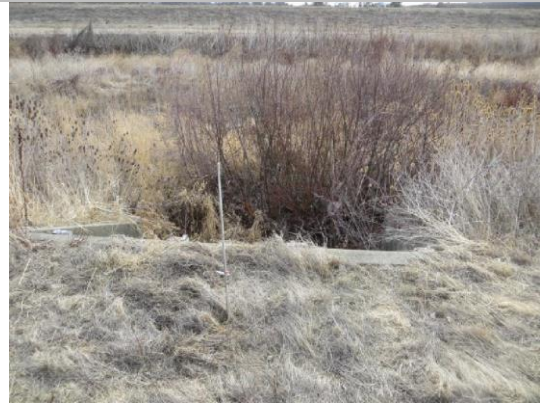
Photo 3 of 3 : UCIP_SP_2017_26947_49791.jpg

Concrete headwall visible on WS berm.

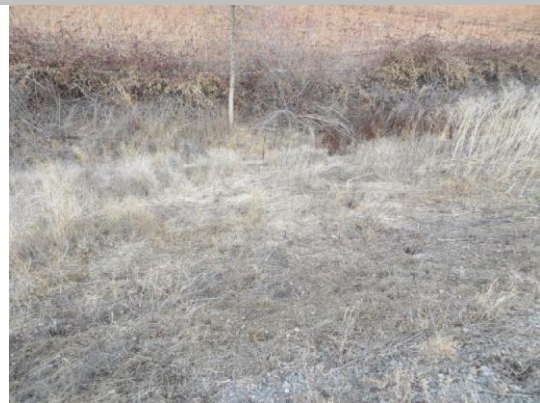
Photo 1 of 3 : UCIP_SP_2017_26948_49797.jpg

Concrete headwall and inlet visible on LS toe.

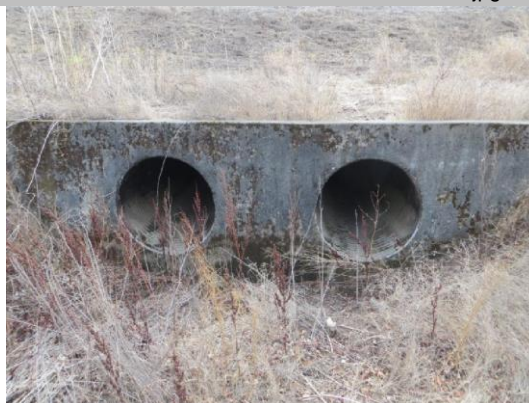
Photo 2 of 3 : UCIP_SP_2017_26948_49796.jpg

Concrete headwall and inlet visible on LS toe.

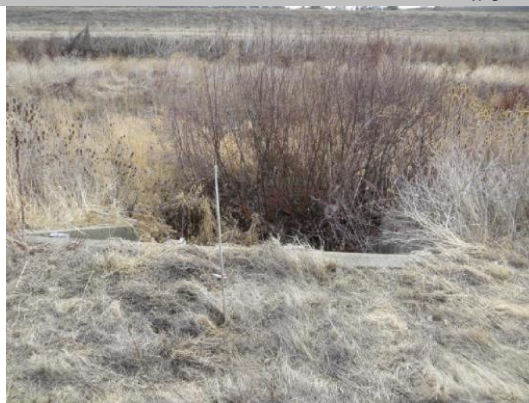
Photo 3 of 3 : UCIP_SP_2017_26948_49795.jpg

Concrete headwall visible on toe of WS berm.

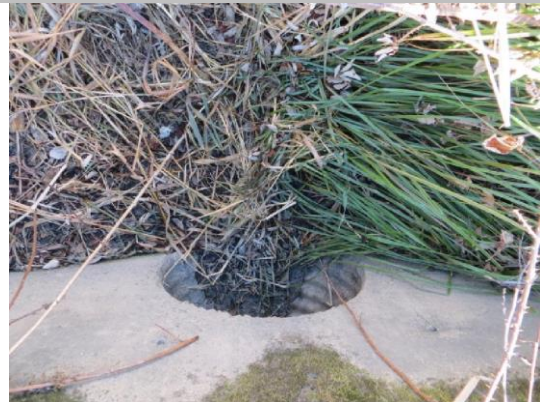
Photo 2 of 3 : UCIP_SP_2017_51472_49753.jpg

Pipe and concrete headwall visible in drainage channel on LS toe.

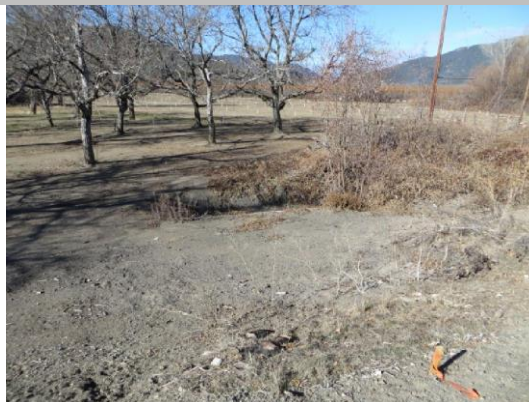
Photo 1 of 3 : UCIP_SP_2017_26924_49762.jpg

Drainpipe visible at LS toe.

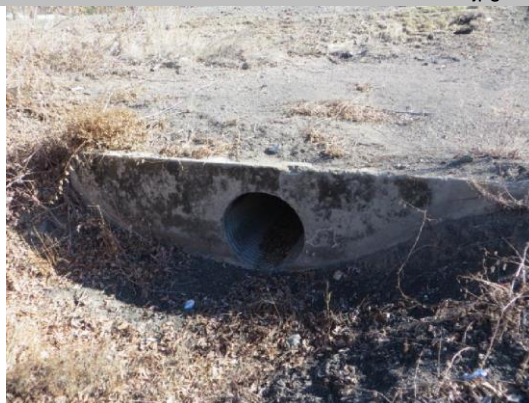
Photo 2 of 3 : UCIP_SP_2017_26924_49761.jpg

Concrete headwall and drainpipe visible at LS toe.

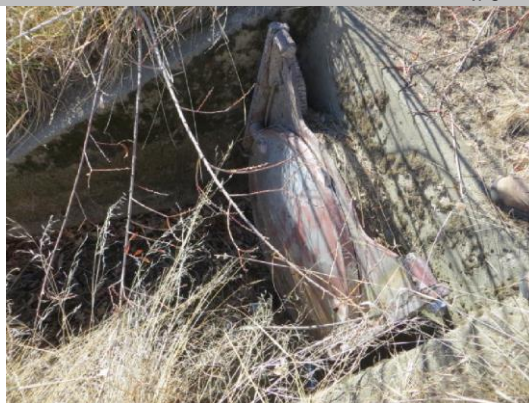
Photo 3 of 3 : UCIP_SP_2017_26924_49760.jpg

Concrete headwall visible off WS berm.

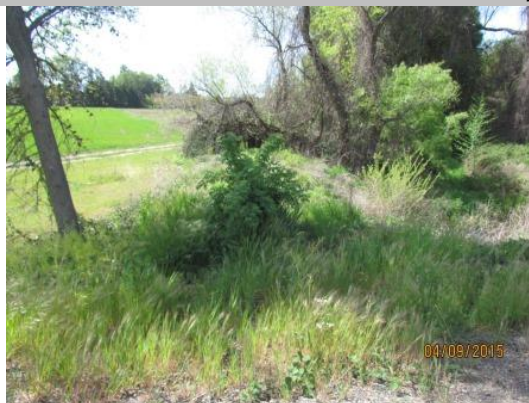
Photo 1 of 1 : SP_2017_NA0009_7_3_20170315_00001.jpg

View of the elderberry along the landside toe.

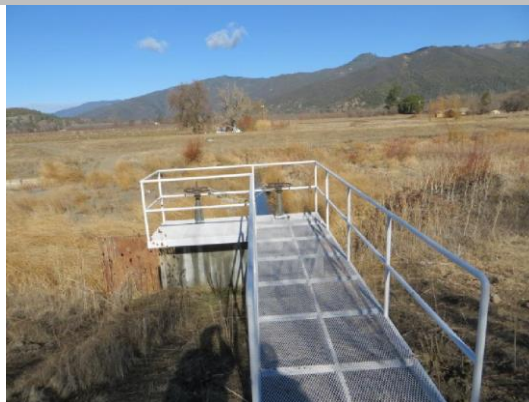
Photo 1 of 3 : UCIP_SP_2017_26897_49712.jpg

Slide gate at steel walkway on WS toe.

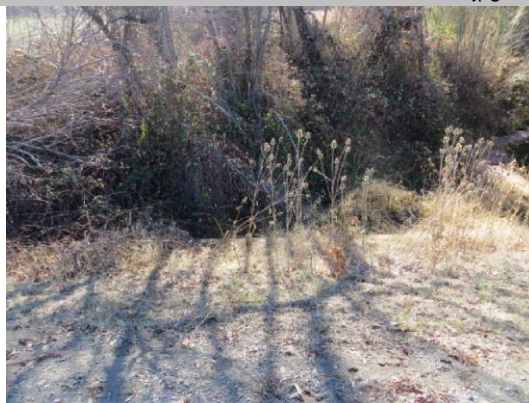
Photo 2 of 3 : UCIP_SP_2017_26897_49711.jpg

Outlet visible at concrete headwall on LS toe.

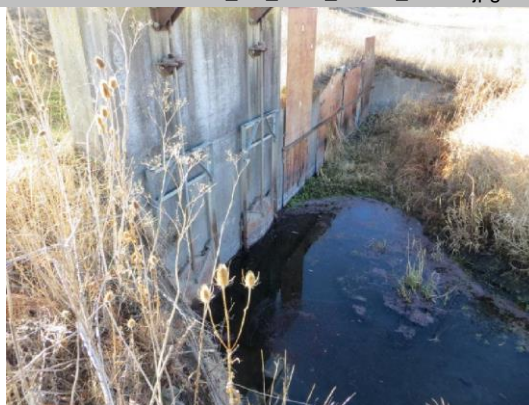
Photo 3 of 3 : UCIP_SP_2017_26897_49710.jpg

Slide gate at concrete headwall on WS toe.

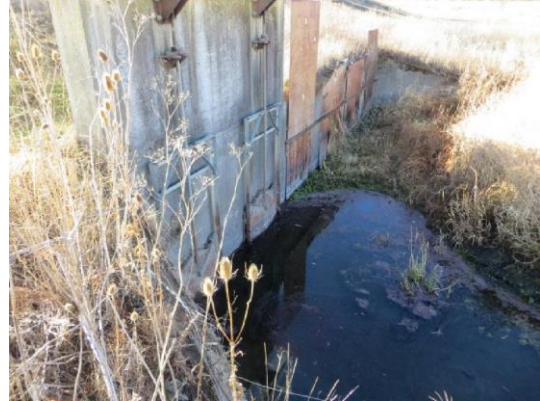
Photo 3 of 3 : UCIP_SP_2017_26891_49680.jpg

Slide gate visible at concrete headwall on WS toe.

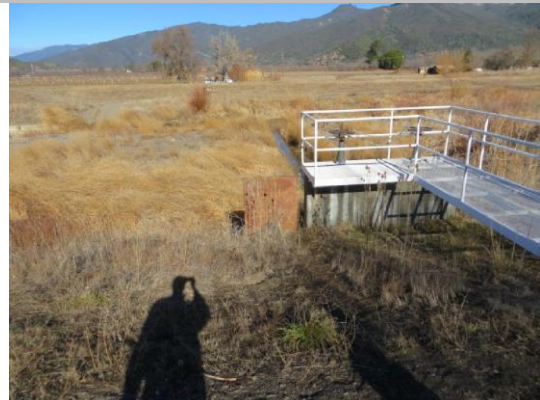
Photo 1 of 3 : UCIP_SP_2017_26888_49666.jpg

Steel slide gate visible at concrete headwall on WS toe.

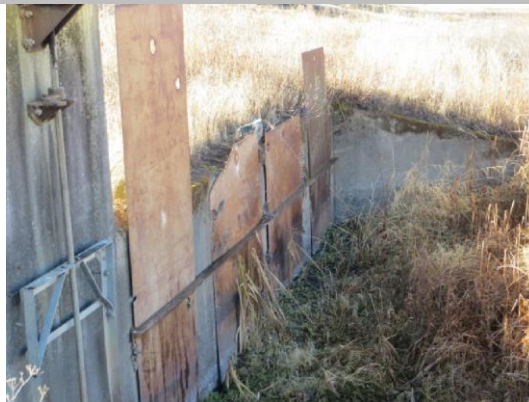
Photo 3 of 3 : UCIP_SP_2017_26888_49664.jpg

Steel slide gate visible at concrete headwall on WS toe.

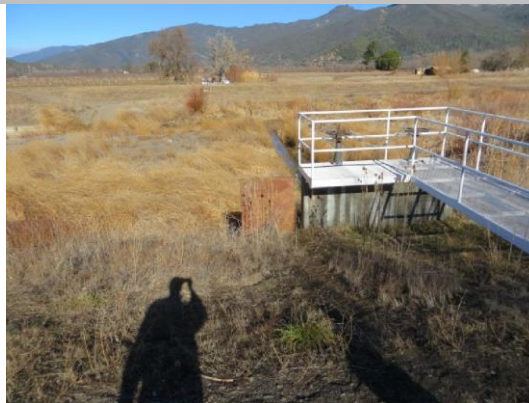
Photo 1 of 3 : UCIP_SP_2017_26885_49634.jpg

Steel plate slide gate visible at headwall on WS toe.

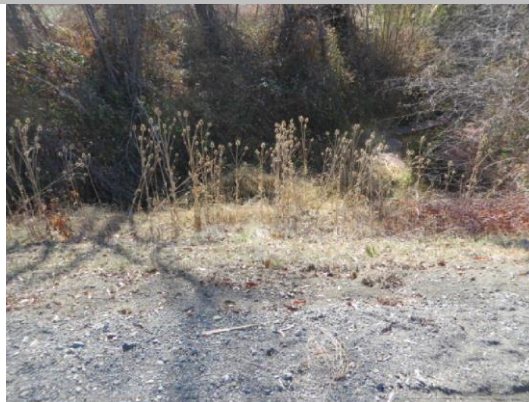
Photo 2 of 3 : UCIP_SP_2017_26885_49633.jpg

Outlet visible at concrete headwall on LS toe.

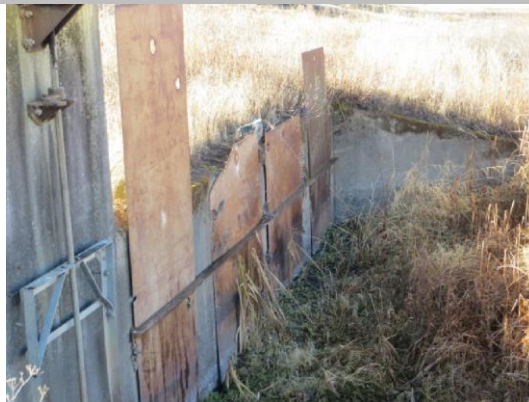
Photo 3 of 3 : UCIP_SP_2017_26883_49620.jpg

Metal slide gate visible at concrete headwall on WS toe.

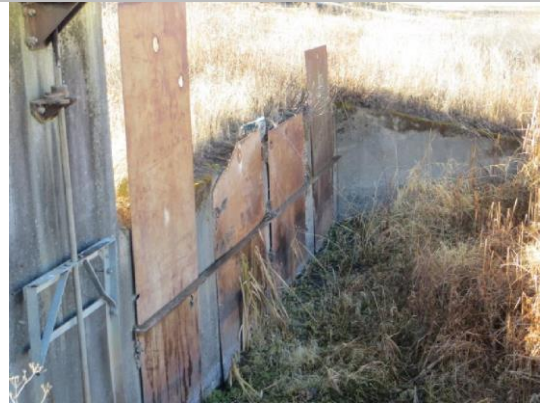
Photo 3 of 3 : UCIP_SP_2017_26877_49608.jpg

Steel slide gate visible at headwall on WS toe.

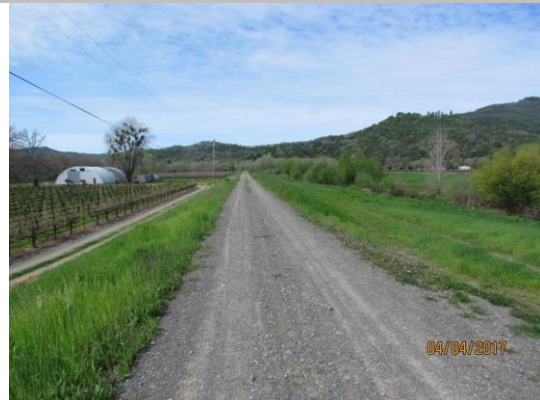
Photo 1 of 1 : SP_2017_NA0009_7_13_20170410_00023.jpg

View of the native grasses on both slopes.
